# Modern Dispense Systems and Coated Brass Equipment – is this up to date? Results of an Investigation

Descriptors: Dispense equipment, coated brass, tap, nozzle, lead, delamination, surface condition

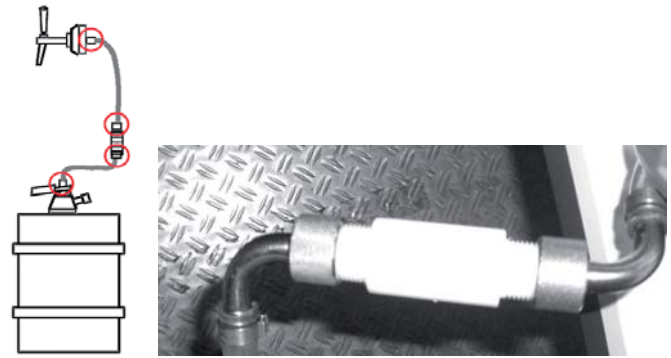
Fig. 1 Test setup for the hose nozzle testing. The circles show the places where the coated brass nozzles were used. On the right picture a double threaded piece is shown [14, 15]

In the trials with hose nozzles, the test setup was prepared as shown in figure 1. In the complete setup, these 4 parts were the only ones made of brass with nickel coating. The coupler was made of stainless steel as well as the ball valve; the feed line and the tap were made of plastic. This setup ensured that the lead concentration measured was activated from the coated brass hose nozzles. The other materials are known as lead-free materials. In addition to the samples in the feed lines, samples were taken directly from the keg engaged as zero-value in order to detect possible lead concentrations already found in the beer.

The beer lines had a length of 2 m and a diameter of 10 mm additionally the filling volume was approx. 175 ml. In the middle of the line, a double threaded piece, made of PTFE, was used. Every type of hose nozzle was tested in three different lines (three lines at a time representing a test set-up with identical nozzles to meet statistical requirements) thus the complete testing setup consisted of 9 lines. Regarding the hose nozzles three different types were assigned: brand new (named "N"), brand new and damaged on purpose (named "Z") and already used (named "A"). The new hose nozzles were bought from a supply shop, the previously used nozzles had been in use at the institute for a period of two years. At this point it has to be stated, that in regards to the results of the BAM (cp. results below), hose nozzles from just one manufacturer were mounted in the test setup.

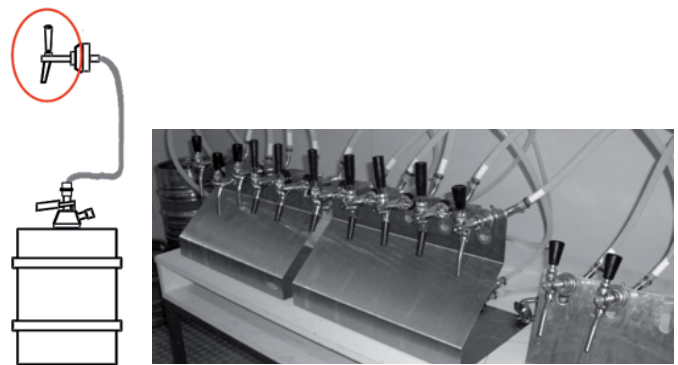
Fig. 2 Test setup for the tap testing, the beer taps used are seen in the right image [15]

For the testing of the taps, a similar test setup was applied (comp Fig. 2). Instead of the coated brass hose nozzles, nozzles made of stainless steel were used. The keg couplers were also made of stainless steel. The double threaded piece was not used, because the testing focus was on the taps. Four different taps were bought, with 3 taps of each type. The whole test setup in this case showed 12 lines. Due to data privacy, the names of the four different manufacturers are not indicated. The taps were named with V1–V4. Tap 1 and 4 were free flow taps, 2 and 3 were compensation taps.

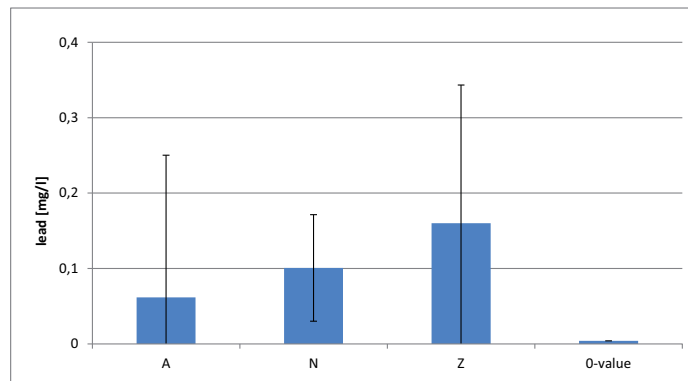
Fig. 3 Lead contents in the beer after the incubation time of 18 hours, dissolved from the hose nozzles

Figure 3 shows the released concentration of lead during the incubation time. It can be seen that the amounts are rather different in the 9 lines. The zero-value indicates the measurement resolution, which is equivalent to non-lead beer which was originally used.

Figure 3 shows an example of one of the analysis results. These results show high amounts of lead in the beer, which tends to come from the surface damaged nozzles. It was also seen that beer from the lines with new nozzles partially delivered higher lead concentrations than the used ones. This is surprising because of the fact that the used nozzles had no protective coating left on the internal side. This situation can be explained due to the inhomogeneous distribution of the lead clusters in the alloy. Depending on the area of such spots and on the right electrochemical preconditions, the elution happens very randomly and more or less intensively. Statistically, there is no difference between new and used nozzles which means that the coating is inefficient and useless against lead release.

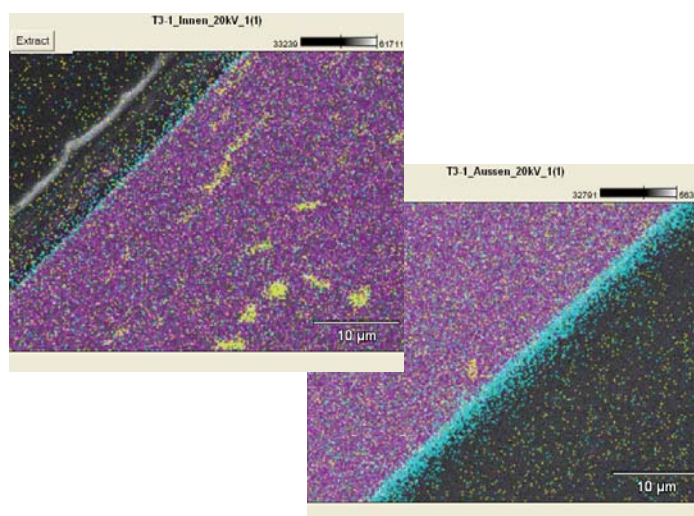
Fig. 4 SEM/EDX picture of a hose nozzle; the white dots indicate the lead clusters in the metal alloy

Figure 4 shows an example of the areas of lead clusters in the cutting area of one of the investigated hose nozzles. It is obvious that the elements are distributed very inhomogeneously. These results were shown in all cases of the analyzed hose nozzles.

The SEM/EDX images show more results. Besides that the quality of brass was insufficient, also the condition of the inner surface was very poor. As the experts of the BAM explained, pores (open, not permeable pores) are partially necessary to avoid stress concentration on the surface. Especially in the use with foodstuff, a protective layer must be placed between the surface layer and the brass. Amazingly, none of the nozzles had shown such a protective layer.

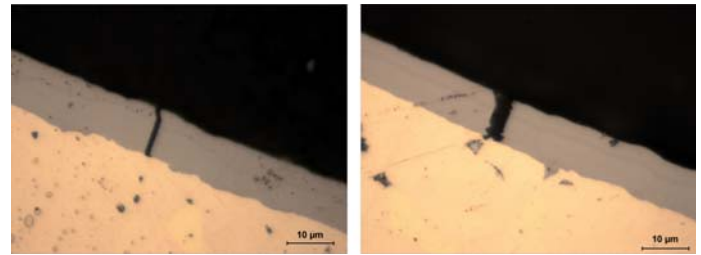
Fig. 5 Light microscope (OM, optical microscopy) picture of a hose nozzle, showing the quality of the coating. The arrows show cracks in the coatings which indicates insufficient and incomplete galvanization [14]

For all four different manufactured hose nozzles, the investigation results from BAM showed that the coating varied in thickness, homogeneity, adhesion and also had scratches and cracks. Figure 5 shows examples of cracks and bad spots in the simple nickel coating of the inner surface. An unexpected result was that in two cases out of the three investigated inner layer coating was inhomogeneous and in most cases was thinner than 3 µm or even not detectable at all. Furthermore, poor adhesion of the coating was detected as mentioned in all hose nozzles as illustrated below.

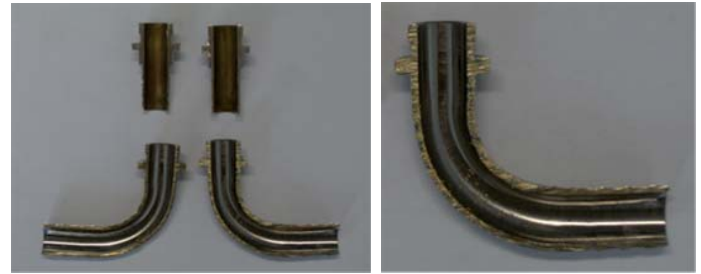
Fig. 6 Picture of a used hose nozzle sliced in half. The arrow refers to the areas where the coating is detached after the trials [14, 15]

For optical analysis, the hose nozzles, which were used for the trials in Weihenstephan, were sectioned in half after the tests. As figure 6 shows, the interior surface of the hose nozzle was damaged. It is clearly visible that the coating had peeled off from the brass.

During the test period, the beer sampled was also checked, beer analysis demonstrated that the detached coating, from the internal side of the hose nozzles, were able to pass into the glasses of beer as little metal chips.

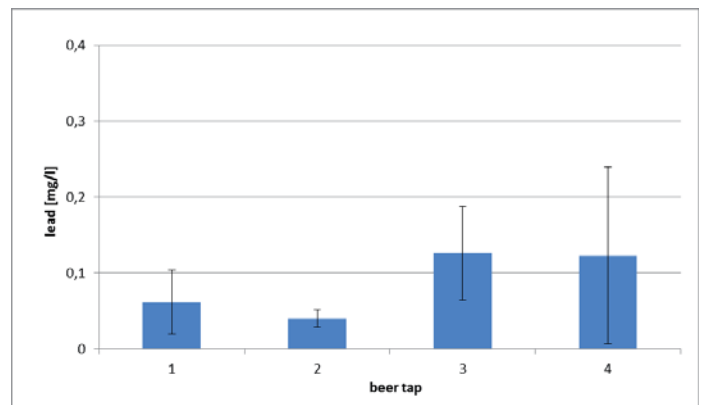
Fig. 7 Lead contents in the beer after incubation time of 18 hours, dissolved from the beer taps

Tap testing exhibited similar results as those of the hose nozzle. However, the conditions on the inner surface were even worse than those conditions in the hose nozzles. In three cases out of four the coating was too thin, inhomogeneous with cracks and other defects. Figure 7 shows the lead content in the analyzed beer samples: The huge confidence intervals can lead one to the conclusion that the lead in the alloy, which is used for the beer taps, is distributed as random as in the hose nozzles. The white dots in Figure 8 prove this argument, again, it is obvious that the lead is distributed in clusters.

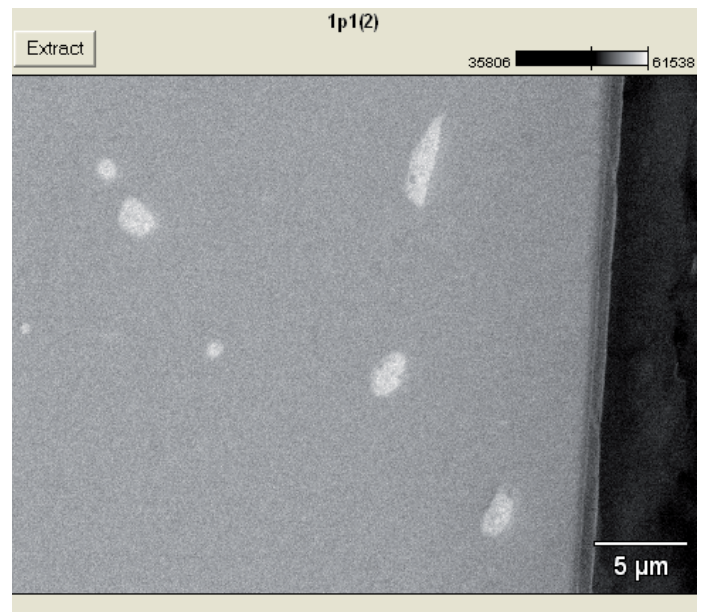
Fig. 8 Lead clusters in the alloy of tap no. 1 (detail of cutting area)

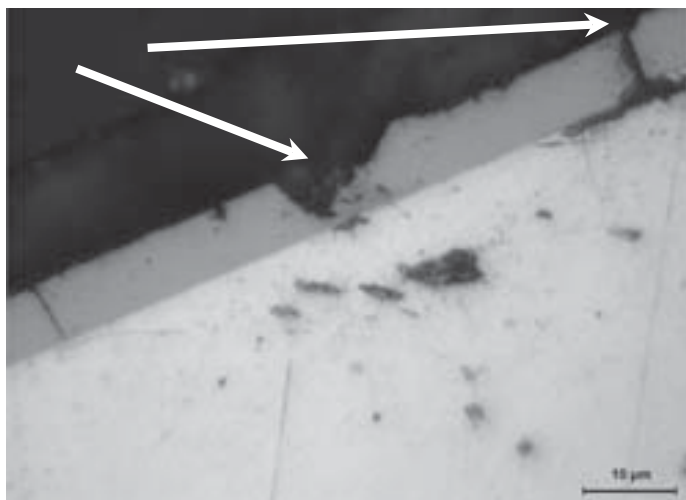
**Fig. 9** An example of the surface defect in a beer tap used for the trials/OM (optical microscopy)

As already seen in the investigations of the nozzles, the quality of the coating is not sufficient for usage with beer. Usually the internal surface should be made of chrome (BAM information), but with the taps investigated, their surfaces were coated with nickel. Most of the internal tap surfaces had defects, insufficient gauge or were imperfect (cp. Fig. 9). Because of an insufficient adhesion of the coating, a delamination was already expected to occur by the BAM experts. The delamination was also observed in reality (cp. Fig. 10).

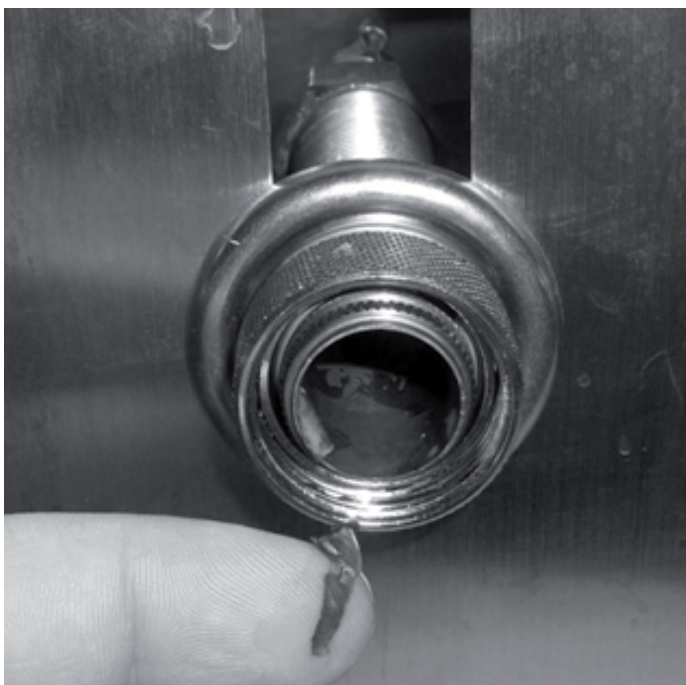
**Fig. 10** Delamination of the internal nickel coating [15]

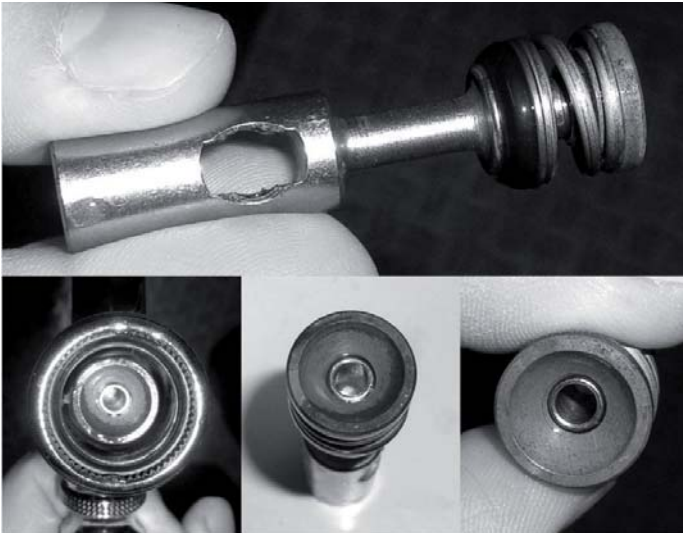
Another big problem, especially after the delamination, is the potential of surface oxidation. Figure 11 and figure 12 show examples of the taps where the components corroded to a very large extent during the testing period. In some cases the coating was completely detached from the inner surface such that; the internal side unveiled pure brass (cp. Fig. 12 at the bottom right).

Fig. 11 Massive corrosion of the components

In conclusion to the investigations it can be said that coated brass equipment is not suitable for use in dispensing systems. Although there are no large health risks due to the amount of lead in the beer, nevertheless the delamination and the corrosion of the materials provide enough reasons to prohibit the use of such coated brass components. In other words: From the present results one can derive that galvanized coated brass equipment should no longer be used in dispensing systems and has to be substituted stepwise with stainless-steel equipment.

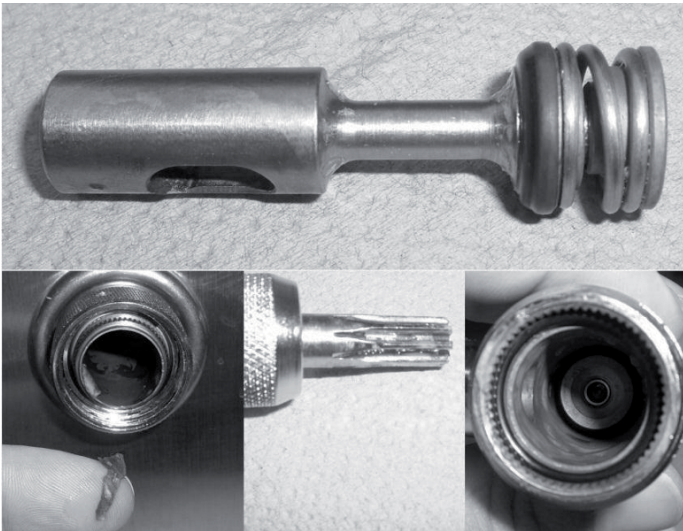
Fig. 12 Massive corrosion of the components [15]
